Survey on Water Cooling System's Failure Analysis for Diesel Electric Locomotives

R. K. Tyagi, Sukanya Borah *

Department of Mechanical Engineering, Amity School of Engineering and Technology, Amity University, Uttar Pradesh, Noida, India

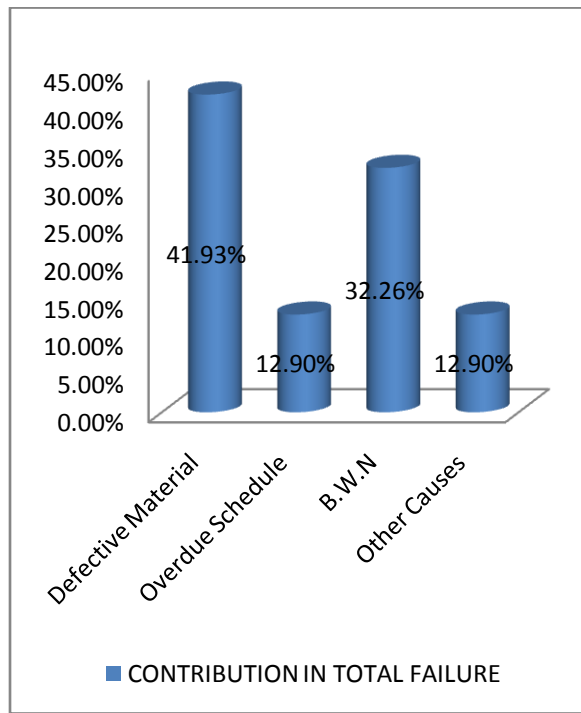
Line Failure

Cause	Contribution In Total Failure
Defective material	41.935 %
Overdue schedule	12.903 %
B.W.N/ mismanagement by crew	32.258 %
Other causes	12.90 %

41.9 % of line failure is due to defective materials which should be an important matter of concern for the railway authorities. It is very necessary to check the materials of the components

- Design deficiency
- Compositional deviational from the standard
- Manufacturing defects.

It is seen that almost 12.9% of line is due to overdue schedule i.e. the components which were meant to be replaced as per schedule were not replaced. For example in many locomotives items like water pump, extension tanks, Victaulic joints and water jumpers are not maintain according to schedule for which leakage, loose of joint of joint and other failures occurs.

32.2% of the failures are due to B.W.N. This may be because of the negligence & lack of knowledge of the technicians. Water leakage from telltale hole of water pump, loose of nut, water leakage from radiator core are the failures which are because of B.W.N but this are the failures which should not have been occurred.

on the very time it was supplied and only then it should be put to used in the locomotives. The main reasons for defective material are –

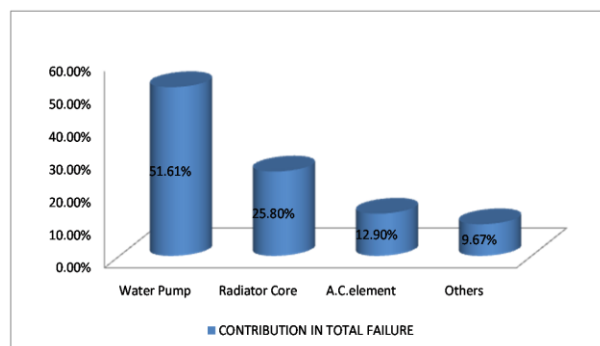
Shed Failure

Components Of W.C.S	Contribution In Total Failure
Water Pump	51.61%
Radiator Core	25.8%
A.C. element	12.9%
Others	9.677%

It is quite clear from the above table that almost half of the W.C.S failures are of the water pump failure. It is also found that the radiator cores suffer many failures. So, proper maintenance of the radiator core is required.
