**Survey on Water Cooling System's Failure Analysis for Diesel Electric Locomotives**

R. K. Tyagi\* and Sukanya Borah\*\*

**ABSTRACT**

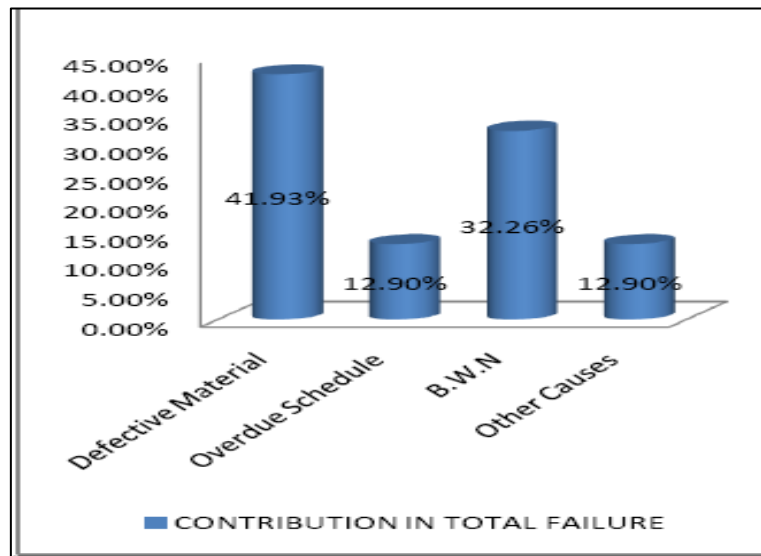
**Line Failure**

<b>Cause</b>	<b>Contribution In Total Failure</b>
Defective material	41.935 %
Overdue schedule	12.903 %
B.W.N/ mismanagement by crew	32.258 %
Other causes	12.90 %

41.9 % of line failure is due to defective materials which should be an important matter of concern for the railway authorities. It is very necessary to check the materials of the components on the very time it was supplied and only then it should be put to used in the locomotives. The main reasons for defective material are –

- Design deficiency
- Compositional deviational from the standard
- Manufacturing defects.

It is seen that almost 12.9% of line is due to overdue schedule i.e. the components which were

meant to be replaced as per schedule were not replaced. For example in many locomotives items like water pump, extension tanks, Victaulic joints and water jumpers are not maintain according to schedule for which leakage, loose of joint of joint and other failures occurs.

32.2% of the failures are due to B.W.N. This may be because of the negligence & lack of knowledge of the technicians.

Water leakage from telltale hole of water pump, loose of nut, water leakage from radiator core are the failures which are because of B.W.N but this are the failures which should not have been occurred.

From the failure analysis we find that most of the failures is because of defective material and this type of failures occurs in items like water jumper, water pump, vent pipe, extension tank, A.C. Element, Radiator fan etc. So, it should be brought under the notice of the manufacturer so that they can take necessary actions for better quality of the items. For that proper study, proper design, proper equipment and proper is required.

Another most important reason for failure is overdue schedule so the authority should be strict regarding the maintenance.

For that proper records should be present and regular inspection is required. It is better to use new components to replace older ones timely.

"Bad Workmanship (B.W.N)" is another cause of failure. This may be due to the ignorance or due to the lack of knowledge. In the whole training period i have notice that many technicians have good practical knowledge but not much of theoretical knowledge. So, there must be a proper platform especially for the workers where they can get both practical and theoretical knowledge.

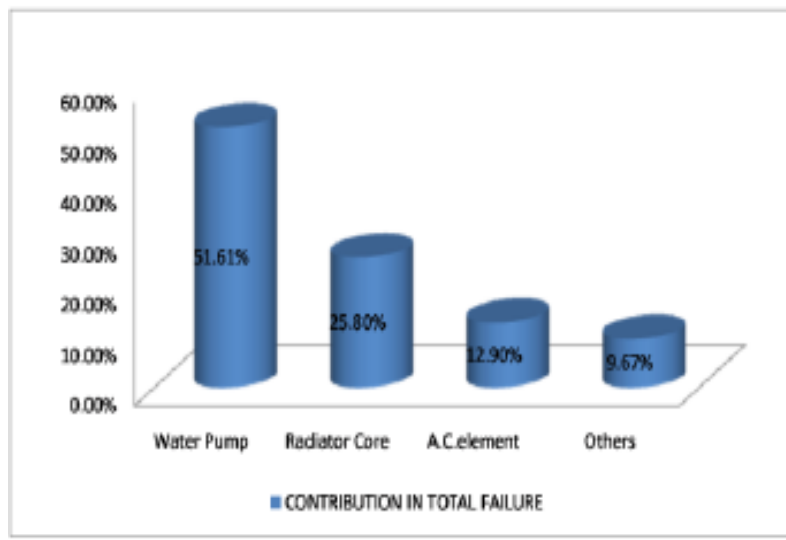
**Shed Failure**

Components Of W.C.S	Contribution In Total Failure
Water Pump	51.61%
Radiator Core	25.8%
A.C. element	12.9%
Others	9.677%

It is quite clear from the above table that almost half of the W.C.S failures are of the water pump failure. It is also found that the radiator cores suffer many failures. So, proper maintenance of the radiator core is required. I have done a very brief analysis on the failure records but even then i could find so many flaws in the maintenance of the W.C.sytem.

From the failure analysis it was found that water pump, radiator core, AC. element, expansion tank etc. are the core components of Water Cooling System where frequently failure occurs. So, the maintenance of these should also be frequent. Experts should be available for each part of the items.
