Modern Engineering Studies on Ancient Building Materials of Sirpur (C.G)

This paper presents results of various engineering tests conducted on some building materials collected from Sirpur (C.G). The tests on Bricks were conducted as per IS 1070:1992 & IS 3495(Part 1 to 4): 1992. The test such as chemical analysis was also conducted on binding material. The test results are interpreted in the context of modern technical specifications.

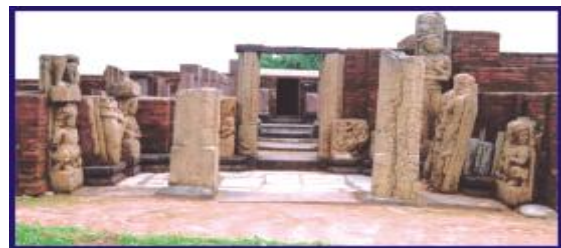
Fig: 1. Anand Prabh Kuti Vihara

Anand Prabhu Kuti Vihar was a place for worship related to the Buddhist monk named 'Anand Prabhu' built in circa 7th-8th cent. A. D. Here, in main cell, a big sculpture of Lord Buddha is installed. All cells are made of bricks and the rooms are open.

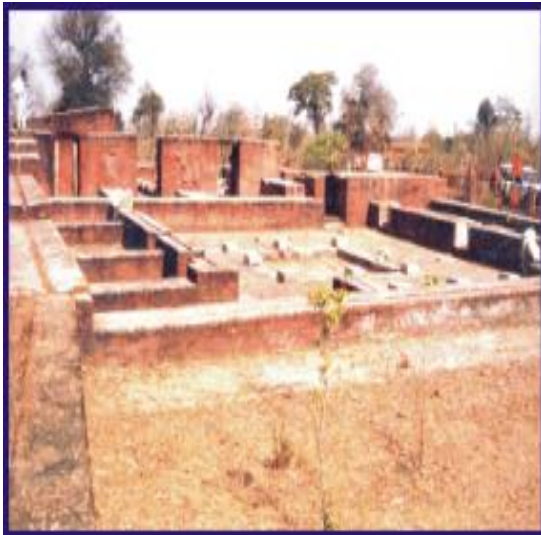
Fig: 2. Swastika Vihara

This monument is contemporary to Anand Prabhu Kuti Vihar at Sirpur situated at the distance of only 400 meters from the said monument. It is said that being in the shape of Swastika (a holy symbol) it was named as Swastika Vihar. A big sculpture of Lord Buddha is kept here in its sanctum. This beautiful Vihar was built just after the Anad Prbh Kuti Vihar in 7th-8th cent. A. D. This is a brick built Buddhist monastery smaller than Anand Prabhu-Kuti.

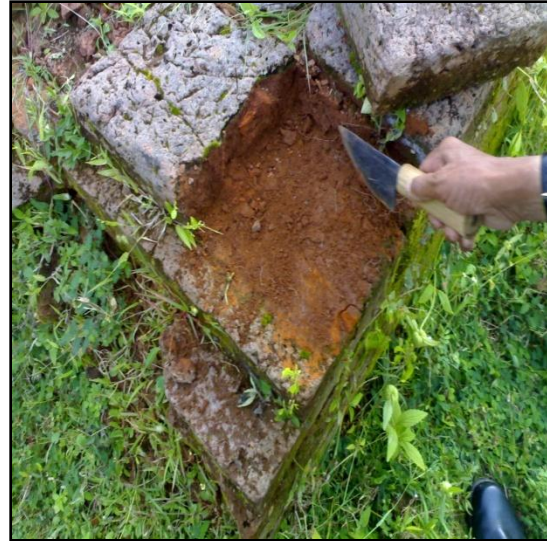
Fig: 3. Collection of Mortar Sample

The Mortar Used In The Brickwork Of Ancient Structure Is A Clay-Slurry Type.

SiO₂ %	Al₂O₃ %	Fe₂O₃ %	K₂O %	CaO %	P₂O₅ %	TiO₂ %	MgO %	Sr %
64.65	12.85	5.85	3.10	3.26	1.80	0.85	0.30	Trs
Na₂O %	MnO %	S %	Zr %	Ba %	Rb %	Pb %	Y %	
0.10	0.14	0.05	0.04	0.02	0.01	Trs	Trs

(SiO₂) and Alumina (Al₂O₃) followed by Fe₂O₃ and Cao. In spite of low percentage of CaO, the mortar have good strength therefore this suggests that some natural polymers must have been added. More research is needed.

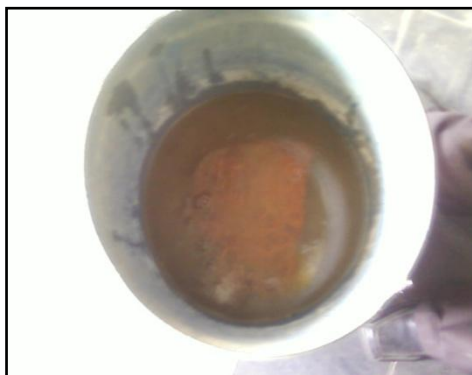
Fig: 5. Determination of water absorption

Dry the specimen in a ventilated oven at a temperature of 105 to 115 degree Celsius till it attains substantially constant mass. Cool the specimen to room temperature and obtain its weight (M1). Specimen warm to touch shall not be used for this purpose.

Immerse completely dried specimen in clean water at a room temperature of 27 + - 2 degree Celsius for 24 hours. Remove the specimen and wipe out any traces of water with a damp cloth and weigh the specimen. Complete the weighing 3 minutes after the specimen has been removed from water (M2).

As per IS 1077:1992, the permissible value is 20%.by weight up to Class Designation 12.5

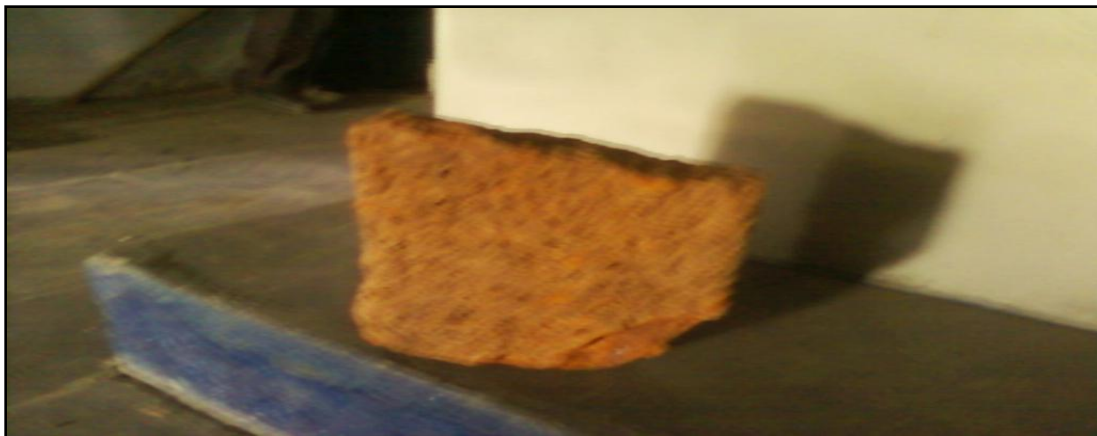
**Fig: 6.** Efflorescence

Place the end of the bricks in the dish, the depth of immersion in water 25 mm. Place the whole arrangement in a warm (for example, 20 to 30 degree Celsius) well ventilated room until all the water in the dish is absorbed by the specimen and the surplus water evaporates. Cover the dish containing the brick with suitable glass cylinder so that excessive evaporation from the dish may not occur. When the water has been absorbed and bricks appear to be dry, place a similar quantity of water in the dish and allow

it to evaporate as before. Examine the bricks for efflorescence after the second evaporation and report the results.

Nil: There is no perceptible deposit of efflorescence.

The bricks when tested in accordance with the procedure laid down in IS 3495 (Part 3):1992 the rating of efflorescence shall not be more than “moderate” up to class 12.5
