Modern Engineering Studies on Ancient Building Materials of Sirpur (C.G)

ABSTRACT

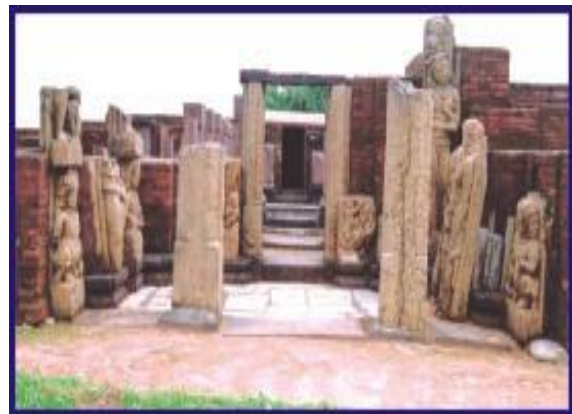
Fig 1: Anand Prabh Kuti Vihara

Anand Prabhu Kuti Vihar was a place for worship related to the Buddhist monk named „Anand Prabhu“ built in circa 7th-8th cent. A. D. Here, in main cell, a big sculpture of Lord Buddha is installed. All cells are made of bricks and the rooms are open.

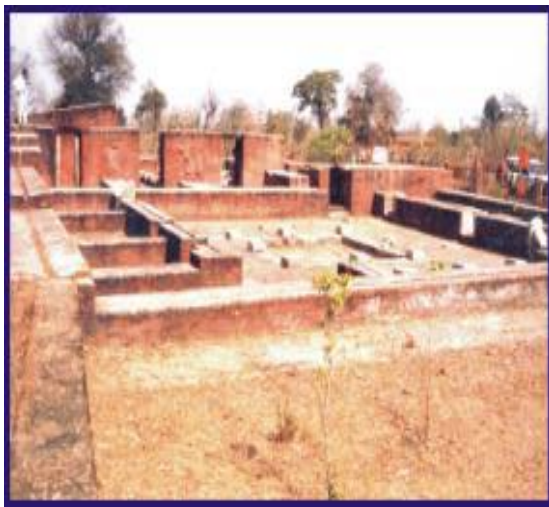
Fig 2: Swastika Vihara

This monument is contemporary to Anand Prabhu Kuti Vihar at Sirpur situated at the distance of only 400 meters from the said monument. It is said that being in the shape of Swastika (a holy symbol) it was named as Swastika Vihar. A big sculpture of Lord Buddha is kept here in its sanctum. This beautiful Vihar was built just after the Anad Prbh Kuti Vihar in 7th-8th cent. A. D. This is a brick built Buddhist monastery smaller than Anand Prabhu-Kuti.

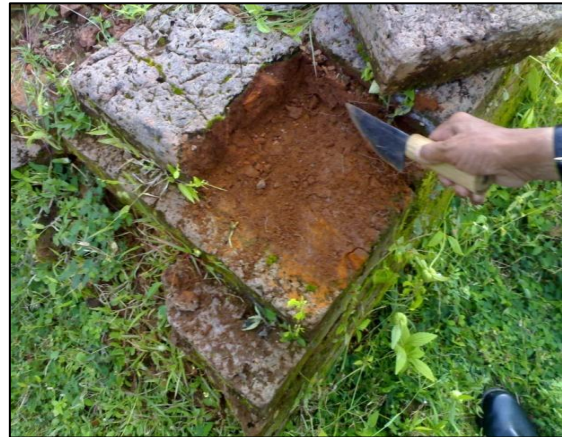
Fig 3: Collection of Mortar Sample

The Mortar Used In The Brickwork Of Ancient Structure Is A Clay-Slurry Type.

From the tests conducted on brick, it appears that the ancient bricks are in no way inferior to modern bricks. From the table of scan report, it can be interpreted that the major constituents are Silica (SiO₂) and Alumina (Al₂O₃) followed by Fe₂O₃ and Cao. In spite of low percentage of CaO, the mortar have good strength therefore this suggests that some natural polymers must have been added. More research is needed.

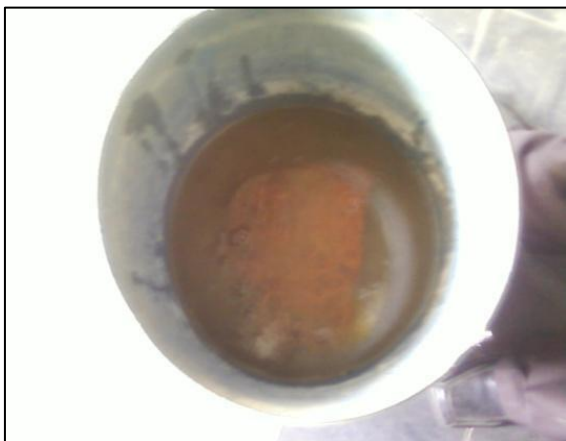
Fig 5: Determination of Water Absorption

Testing procedure As per IS 3495 (Part 2): 1992

Dry the specimen in a ventilated oven at a temperature of 105 to 115 degree Celsius till it attains substantially constant mass. Cool the specimen to room temperature and obtain its weight (M1). Specimen warm to touch shall not be used for this purpose.

Immerse completely dried specimen in clean water at a room temperature of 27 + - 2 degree Celsius for 24 hours. Remove the specimen and wipe out any traces of water with a damp cloth and weigh the specimen. Complete the weighing 3 minutes after the specimen has been removed from water (M2).

As per IS 1077:1992, the permissible value is 20%.by weight up to Class Designation 12.5

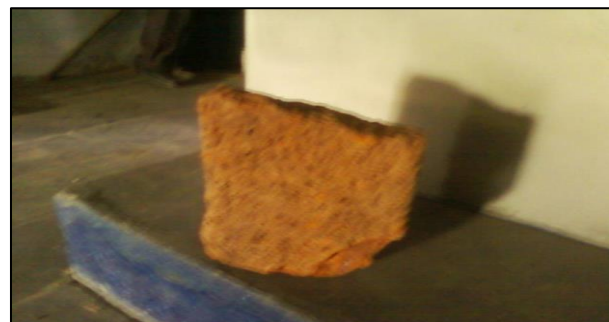
Fig 6: Efflorescence

Testing procedure: As per IS 3495 (Part 3):1992

Place the end of the bricks in the dish, the depth of immersion in water 25 mm. Place the whole arrangement in a warm (for example, 20 to 30 degree Celsius) well ventilated room until all the water in the dish is absorbed by the specimen and the surplus water evaporates. Cover the dish containing the brick with suitable glass cylinder so that excessive evaporation from the dish may not occur. When the water has been absorbed and bricks appear to be dry, place a similar quantity of water in the dish and allow it to evaporate as before. Examine the bricks for efflorescence after the second evaporation and report the results. The liability to efflorescence shall be reported as „nil“, „slight“, „heavy“, or „serious“ in accordance with the following definitions:

- (i) **Nil** - When there is no perceptible of efflorescence.
- (ii) **Slight** - When not more than 10 percent of the exposed area of the brick is covered with a thin deposit of salts.
- (iii) **Moderate** - When there is a heavier deposits than under „slight“ and covering up to 50 percent of the exposed area of the brick surface but unaccompanied by powdering or flaking of the surface.
- (iv) **Heavy** - When there is a heavy deposit of salts covering 50 percent or more of the exposed area of the brick surface but unaccompanied by powdering or flaking of the surface.
- (iv) **Serious** - When there is a heavy deposit of salts accompanied by powdering and or flaking of the exposed surfaces.

Nil: There is no perceptible deposit of efflorescence. The bricks when tested in accordance with the procedure laid down in IS 3495 (Part 3):1992 the rating of efflorescence shall not be more than “moderate” up to class 12.5
