Failure Analysis of First Stage Gas Turbine Blade

Keywords: Gas Turbine Blade, Creep, Corrosion, Fatigue

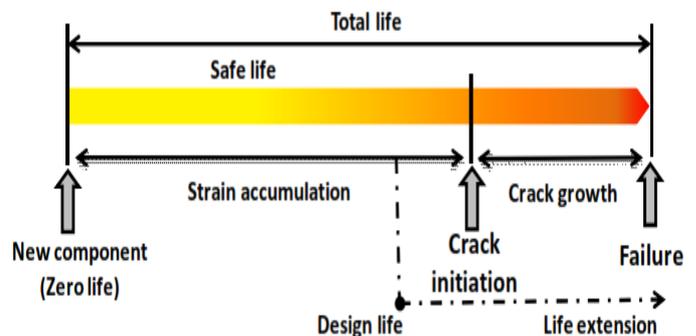
Fig. 3 Creep life span of hot section components due to deformation

Creep behavior is one of the most critical factors determining the integrity of elevated temperature components, because such components can slowly and continuously deform under constant stress over a period of time. The temperature and time dependence of creep deformation indicates that it is thermally activated process. This deformation is the result of Dislocation climb, Vacancy Diffusion, and Grain Boundary sliding. Creep leads to a fracture in components at static stress. Creep is the largest potential problem in applications involving high temperatures and high stress. Betten have described how micro-cracks begin on the surface and propagate until they link into macro-cracks and become visible at the tertiary stage of creep as shown in Fig.[3].
