Failure Analysis of First Stage Gas Turbine Blade

Sushila Rani

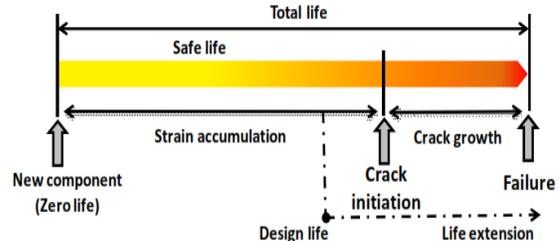
Fig: 3: Creep life span of hot section components due to deformation

Creep behavior is one of the most critical factors determining the integrity of elevated temperature components, because such components can slowly and continuously deform under constant stress over a period of time. The temperature and time dependence of creep deformation indicates that it is thermally activated process. This deformation is the result of Dislocation climb, Vacancy Diffusion, and Grain Boundary sliding. Creep leads to a fracture in components at static stress. Creep is the largest potential problem in applications involving high temperatures and high stress. Betten have described how micro-cracks begin on the surface and propagate until they link into macro-cracks and become visible at the tertiary stage of creep as shown in Fig.[3].
