**Failure Analysis of First Stage Gas Turbine Blade**

**Keywords:** Gas Turbine Blade; Creep; Corrosion; Fatigue.

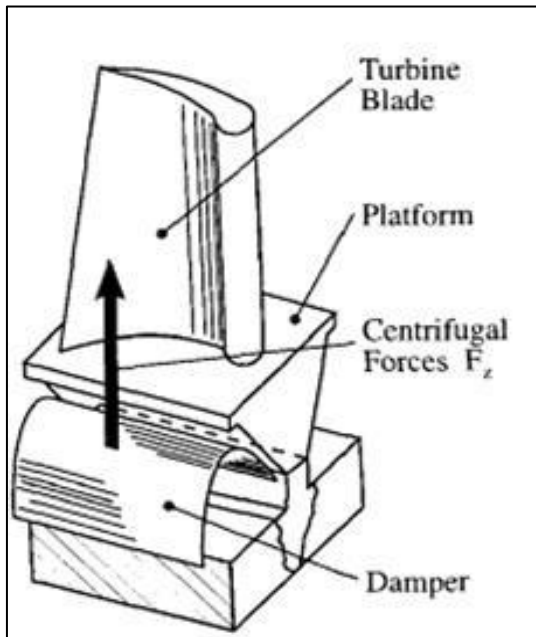
**Fig 1: Gas Turbine Blade**
