Failure Analysis of First Stage Gas Turbine Blade

ABSTRACT

Keywords: Gas Turbine Blade; Creep; Corrosion; Fatigue.

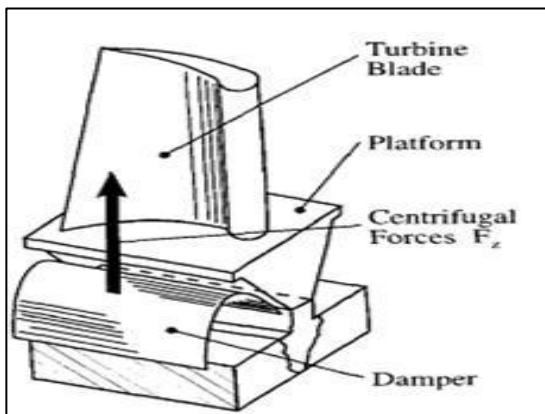
Fig 1: Gas Turbine Blade

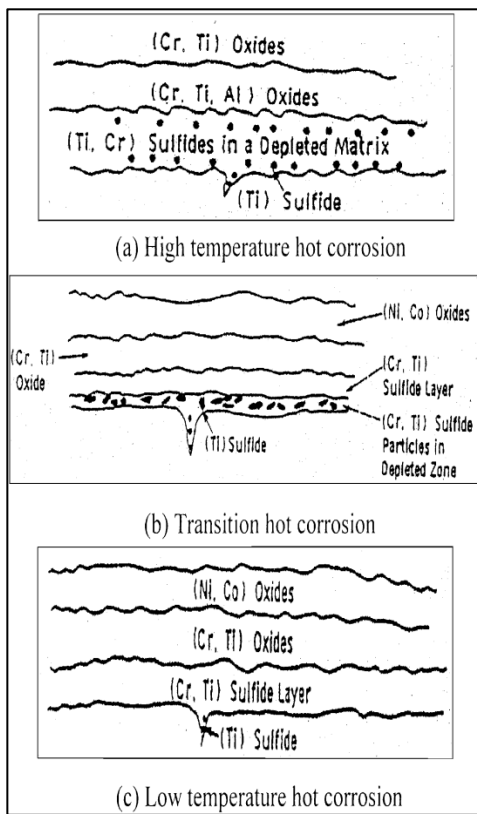
Fig 2: Types of Hot Corrosion

By using an electron beam analyzer, it is found that sulphide particles of chromium and titanium are present in a region below the surface scale which consists of chromium oxide Fig 2(a).

By using an electron beam analyzer, it is found that sulfide particles of chromium and titanium form a continuous layer and the surface scale contains un-protective oxides of Nickel and Cobalt Figure 2(c).

During services, there are corrosion found which has features of both HTHC and LTHC. Hence the name given to this type of corrosion is Transition Hot Corrosion. By using an electron beam analyzer, It is found that the sulfides of chromium and titanium are increasingly agglomerated into large interconnecting sulfide networks and surface scales contains the oxide of Nickel and Cobalt Fig 2(b).

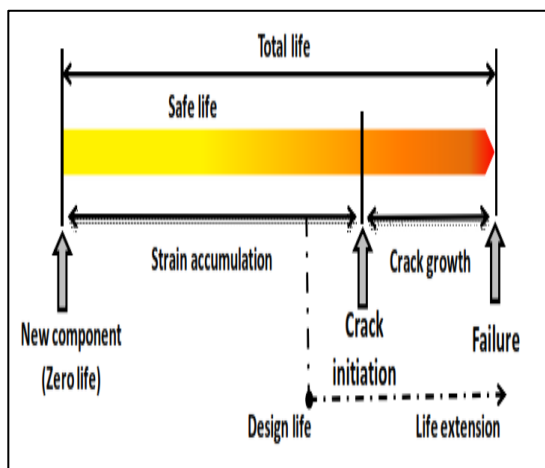
Fig 3: Creep Due to Life Span of Hot Section Components Deformation

can slowly and continuously deform under constant stress over a period of time. The temperature and time dependence of creep deformation indicates that it is thermally activated process. This deformation is the result of Dislocation climb, Vacancy Diffusion, and Grain Boundary sliding. Creep leads to a fracture in components at static stress. Creep is the largest potential problem in applications involving high temperatures and high stress. Betten have described how micro-cracks begin on the surface and propagate until they link into macro-cracks and become visible at the tertiary stage of creep as shown in Fig.[3].
