Porcelain versus Polymer Insulator- A Changing Era in Transmission Lines

ABSTRACT

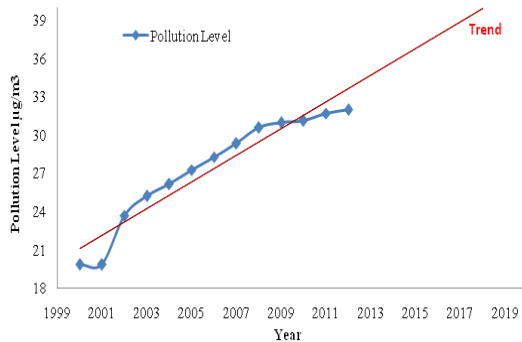
Fig 1: Trend of pollution level in India [1]

The graphical representation of the pollution level in India is given below in Fig.1 [1].

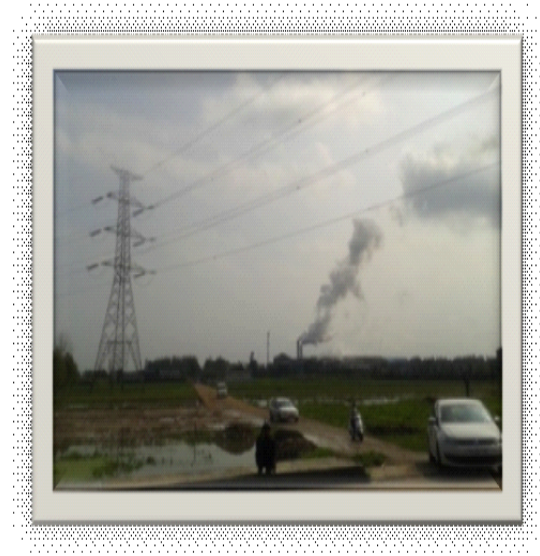
Fig 2(a) : Source of Pollution on Insulators from Power Plants

The pictorial representation of the pollution deposit can be seen in Fig.2 (a) & (b) as given under-

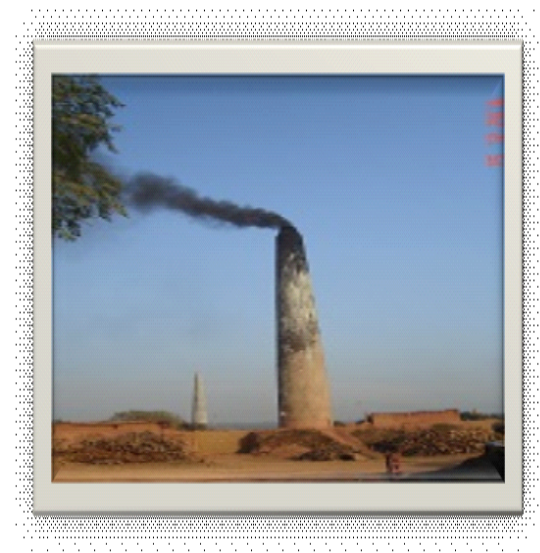
**Fig 2(b) : Source of Pollution on Insulators from brick kilns**

The level of deposit on insulators mostly depends upon wind speed and direction. It also depends upon the area /locality from source of pollution. Clouds & fog during winters acts as a catalyst to create flashovers.

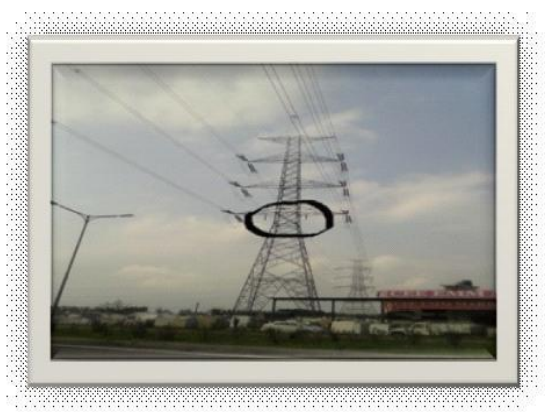
Fig 3: Deposition of Pollution on Insulators

The deposits on insulators are measured in a technical terms called as ESDD (equivalent salt deposit density) and can be seen in Fig.3.

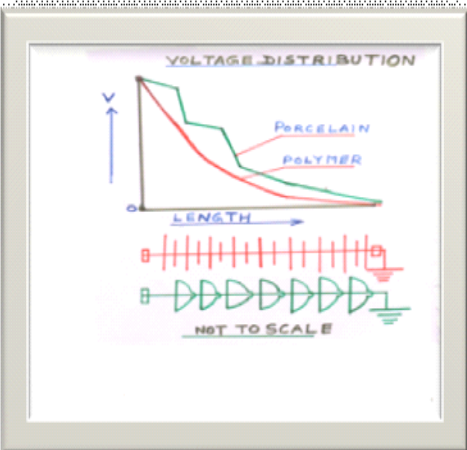
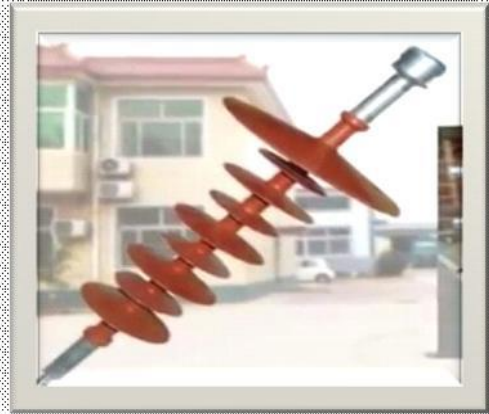
The different figures indicating the polymer based insulators are given below in Figures 4(a)-(d).

- I One of another major advantage of polymers is that voltage distribution is uniform all along length of string, hence no chance of flash over /overshoot exists.
- ii Another advantage of polymers is of its flexibility in design/shape. It can be given any type of shape to obtain required creep distance suitable to customers.

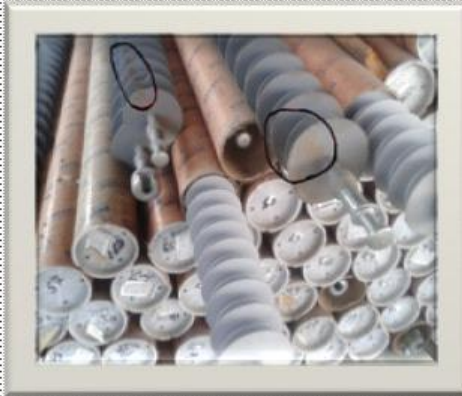
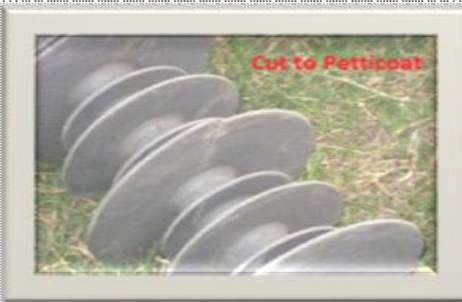
The pictures of different limitations of the polymer based insulators are presented below in figures 5(a)-(d)

- I Eating by rats etc during storage
- ii Notching by birds
- 7. iii. In the event of damage, whole string requires replacement. Whereas in porcelain replacement of damaged /broken insulators is possible.
- iii Bad storage- Due to bad storage petticoat has a tendency to shear. Polymers have also tendency to develop algae, fungus and lichens. This is bluish-green and yellowish type deposit on petticoats. This reduces ph value, lowers hydrophobicity and decolourisation, finally drying the bands leading to breakage of the insulators.
